NE 22500 State Rt. 3  
 Belfair, Wa 98528  
 360-731-2602  
 WA State Lic. Home Inspector # 1087  
 Inspector: John van Dijk

# Property Inspection Report

Client(s): Mr. and Mrs. Smith  
 Property address: 111 First Street.  
 Anytown, WA  
 Inspection date: Saturday, May 17, 2014

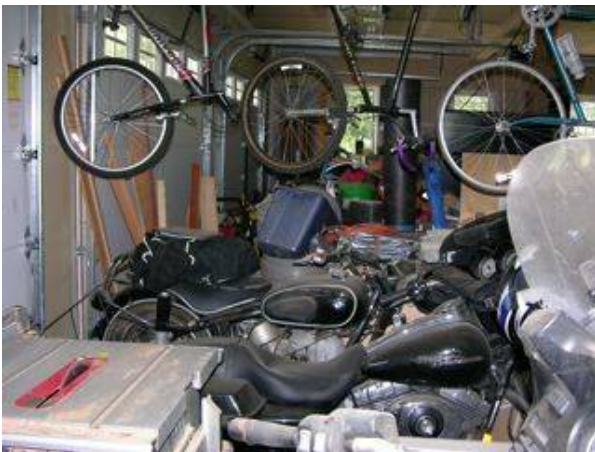
Many areas and items at this property were obscured by furniture and personal belongings. This often includes but is not limited to walls, floors, windows, inside and under cabinets, under sinks, on counter tops, in closets, behind window coverings, under rugs or carpets, and under or behind furniture. Areas around the exterior, under the structure, in the garage and in the attic may also be obscured by stored items. The inspector in general does not move personal belongings, furnishings, carpets or appliances. When furnishings, stored items or debris are present, all areas or items that are obscured, concealed or not readily accessible are excluded from the inspection. The client should be aware that when furnishings, stored items or debris are eventually moved, damage or problems that were not noted during the inspection may be found.

Photo 1-1  
Personal belongings in the garage during the inspection

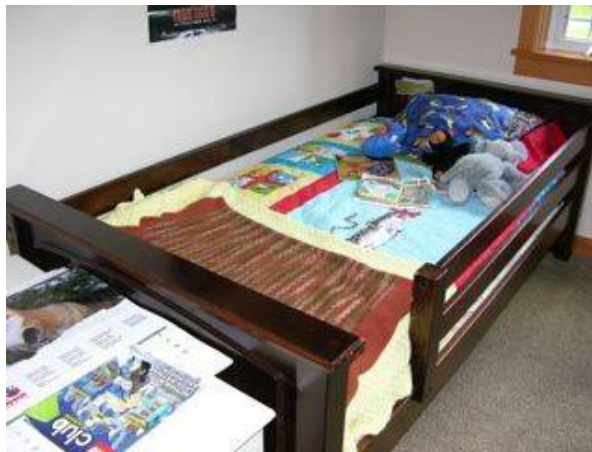
Photo 1-2  
Furniture present during the inspection

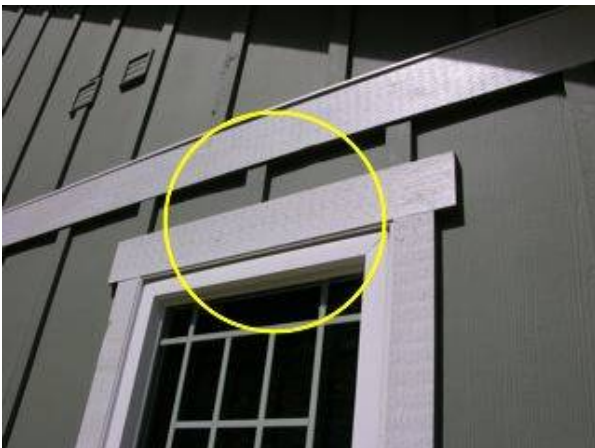
Photo 2-1

The windows on the south east side of the residence are missing the "Z" metal flashing above the windows or trim. Better building practices call for such flashings, which greatly reduce the chance of leaks above windows and doors. Without this flashing, caulk and paint must be maintained or water can enter the wall structure and cause rot and possible structural damage. Depending on the exposure (e.g. roof overhang, height of exterior wall, direction of prevailing rain) this may or may not be an issue. The client should monitor these areas in the future and maintain caulk and paint as necessary.

Windows on the south east side missing Z metal flashing.

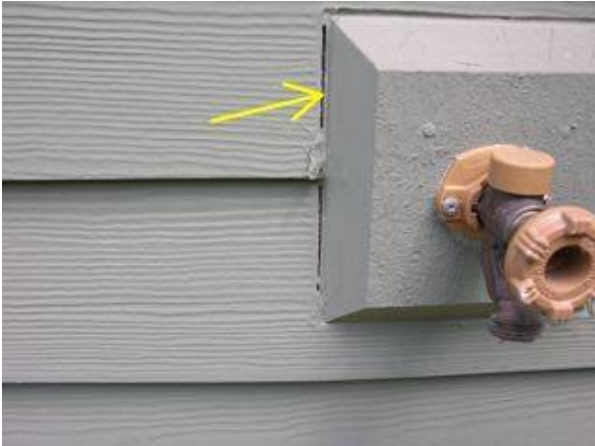
Caulk was missing in some areas. For example, at wall penetrations and some trim. Recommend that a qualified person renew or install caulk as necessary. Where gaps are wider than 1/4 inch, an appropriate material other than caulk should be used. For more information, visit:

Photo 3-1  
Needs additional caulking

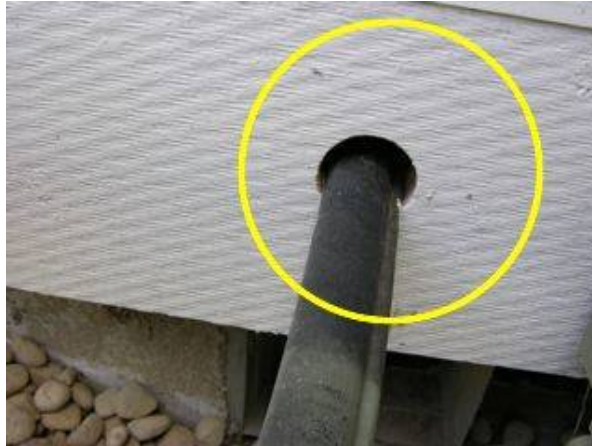
Photo 3-2  
Caulk penetrations

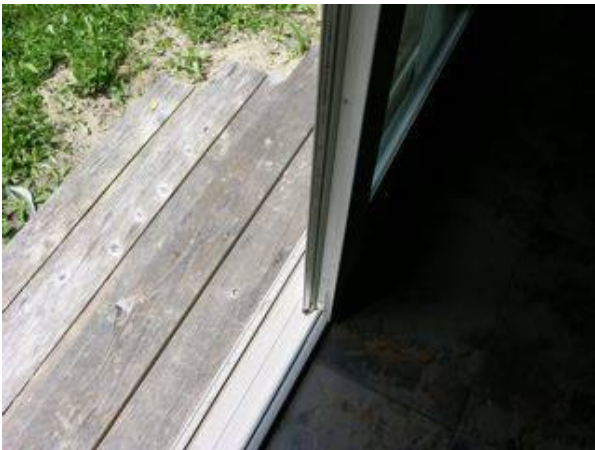
The steps leading off the back of the residence appear to be a temporary installation. They are missing a landing and are not attached to the residence using lags or proper rim joist connection. At a minimum be aware that this condition exist until a proper landing and stairs are constructed.

Photo 4-1  
Temporary landing and steps off the rear sliding glass door

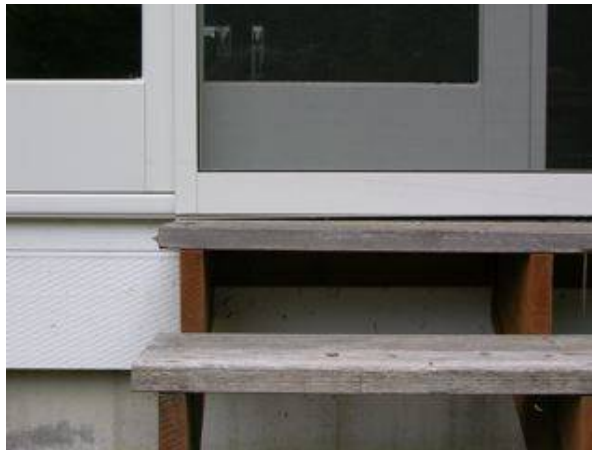
Photo 4-2  
Temporary landing and steps off the rear sliding glass door

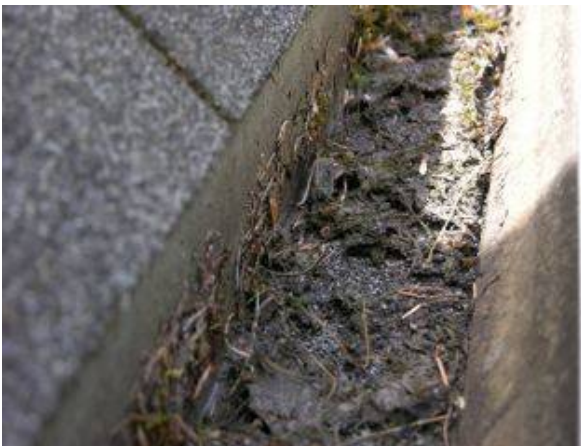
5) 🛠️💧 Significant amounts of debris have accumulated in one or more gutters. Gutters can overflow and cause water to come in contact with the building exterior, or water can accumulate around the foundation. This is a conducive condition for wood-destroying organisms. Recommend cleaning gutters and downspouts now and as necessary in the future.

Photo 5-1  
Debris buildup in the gutters

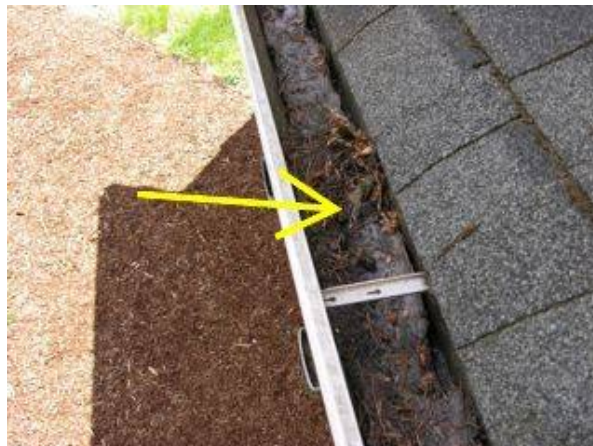
Photo 5-2  
Debris in the gutters

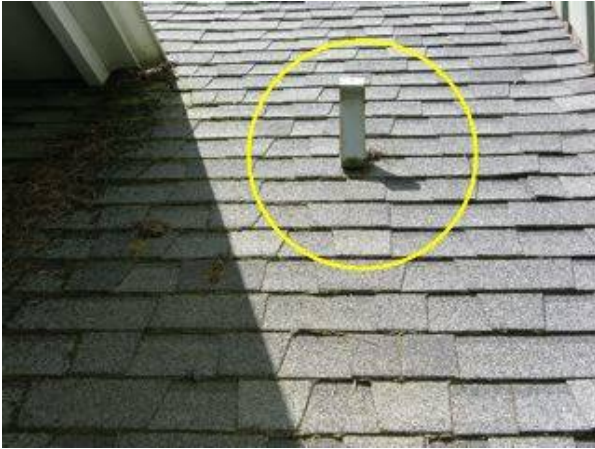
Photo 6-1

A roofing bracket was left on the roof. Leaks can occur as a result. This is a conducive condition for wood-destroying organisms. Recommend a qualified person remove the roofing bracket.

Roofing bracket left on the roof.

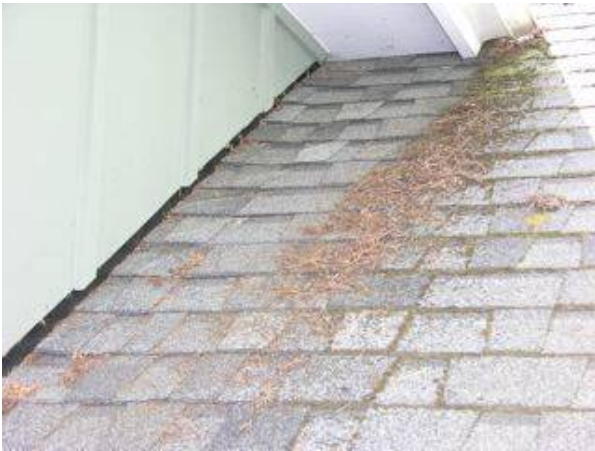
Photo 7-1

Significant amounts of debris such as leaves, needles, seeds, etc. have accumulated on the roof surface. Water may not flow easily off the roof, and can enter gaps in the roof surface. Leaks can occur as a result. This is a conducive condition for wood-destroying organisms. Recommend cleaning debris from the roof surface now and as necessary in the future.

Debris on the roof surface.

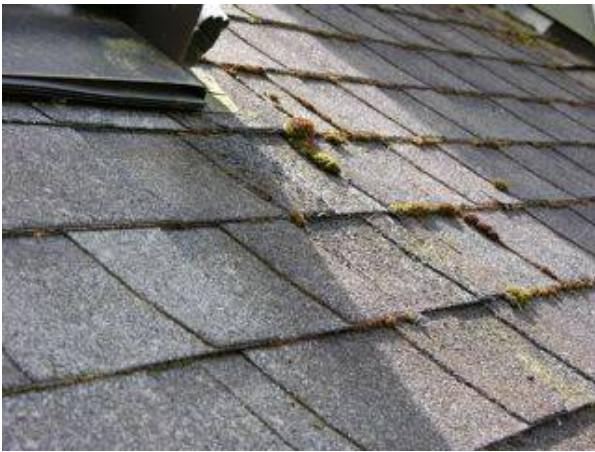
Moss was growing on the roof. As a result, shingles can lift or be damaged. Leaks can result and/or the roof surface can fail prematurely. Efforts should be made to kill the moss during its growing season (wet months). Typically, zinc or phosphate-based chemicals are used for this and must be applied periodically. For information on various moss treatment products and their pros and cons, visit:

Photo 8-1  
Moss growing on the roof. May require treatment.

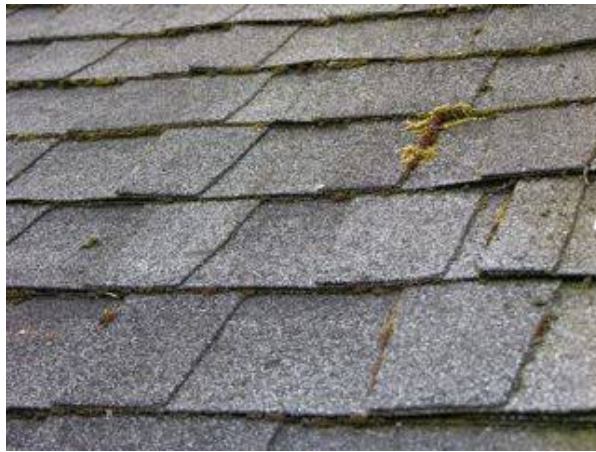
Photo 8-2  
Moss growing on the roof. May require treatment.

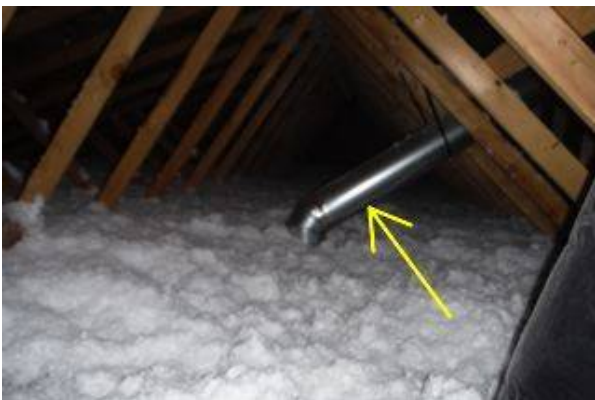
The kitchen exhaust duct in the the attic was not insulated. This can result in moisture forming inside the duct or "sweating" on the outside of the duct depending on the surrounding air temperature and the exhaust air temperature. Recommend that a qualified person install insulation on exhaust ducts per standard building practices.

Photo 9-1  
Exhaust ducts in the attic not insulated.

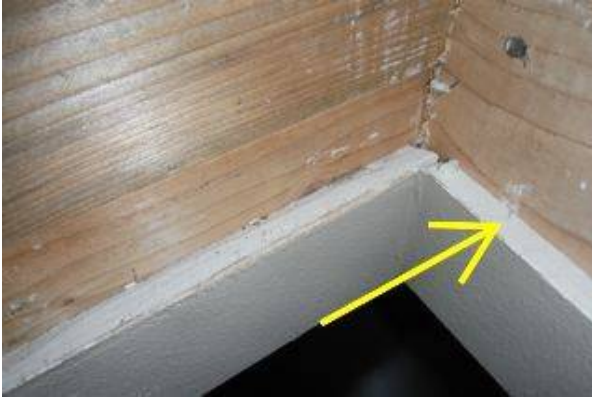
Photo 10-1

The attic hatch located in the upstairs hallway is missing the weather stripping. Weatherstripping should be

Attic hatch is missing weather stripping

installed around hatches or doors as necessary to prevent heated interior air from entering the attic. For more information, visit:

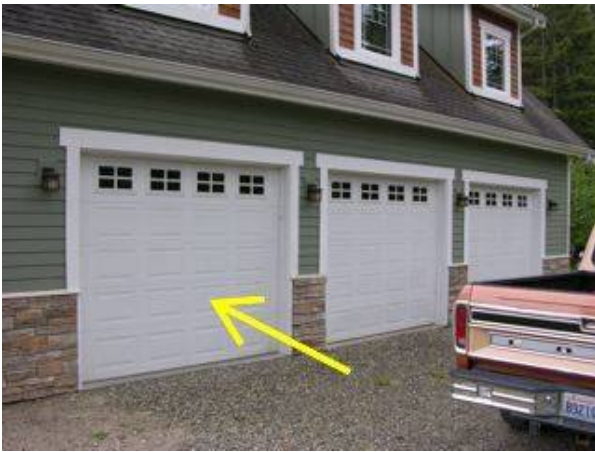
All three garage door openers failed the auto reverse test. When a 2 inch object is placed under the door when closing all three doors failed to auto reverse. This is a potential safety hazard. A qualified contractor should evaluate and repair as necessary.

The auto-reverse force setting for the door on the left (when facing the garage from the exterior) failed when moderate resistance was applied to the door midway as it was closing. This is a potential safety hazard. A qualified contractor should evaluate and repair as necessary. For more information on garage door safety issues, visit:

Photo 12-1  
Left door (viewed from the outside) failed the midway auto reverse test.

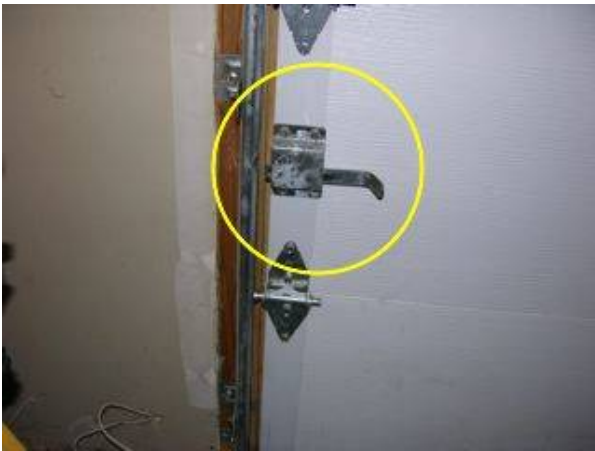
All three garage vehicle doors had an automatic opener installed and the manual lock mechanism on the doors have not been removed or permanently disabled. The automatic opener can be damaged, or injury can occur if the automatic door opener is operated with the manual lock engaged. A qualified person should disable or remove the lock mechanism per standard building practices.

Photo 13-1  
Garage door locks present with garage door openers. All three doors

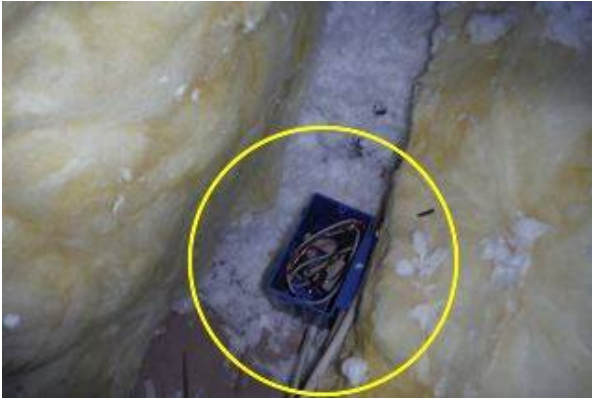
The cover plates for a junction box in the attic was missing. These plates are intended to contain fire and prevent electric shock from occurring due to exposed wires. Recommend that a qualified person install cover plates where necessary.

Photo 14-1  
Open box in the attic

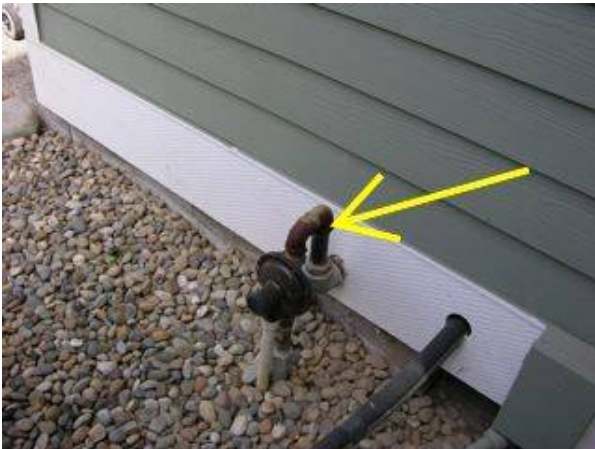
Steel piping for the gas service located outside was significantly corroded. Gas leaks can result. Recommend evaluation by a qualified contractor to determine if piping needs replacing. If not, then a qualified person should prep and paint lines as necessary with a rust-preventative paint. Very corroded pipes should be replaced by a qualified contractor.

Photo 17-1  
 Corroded steel gas piping on the exterior of the residence.

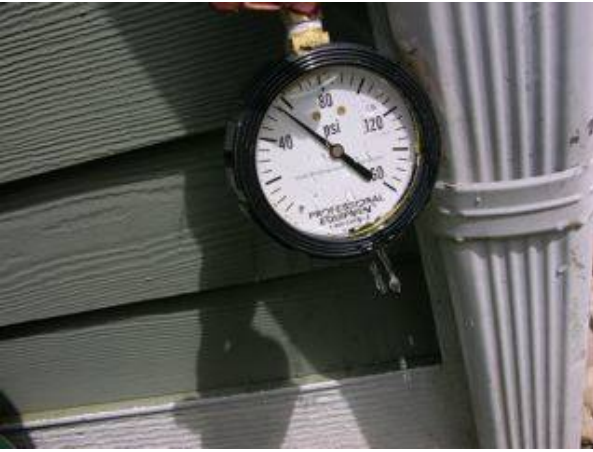
The hose bib located at the rear of the residence leaked when tested. When hose bibs leak while turned off, it's often caused by a worn valve seat or a loose bonnet. When hose bibs leak while turned on, it may be due to worn "packing" around the stem or a defective backflow prevention device. Recommend that a qualified plumber repair as necessary.

Photo 18-1  
Hose bib leaked while under test.

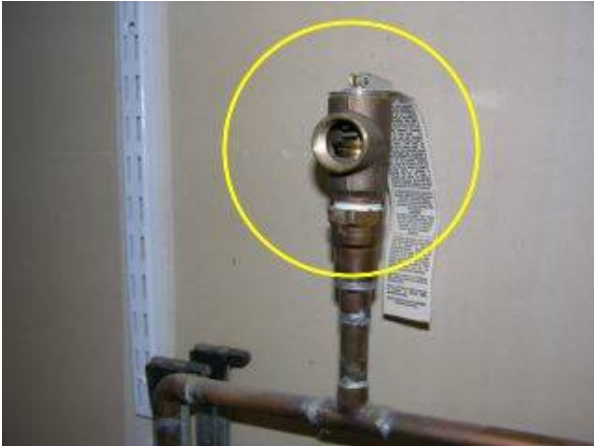
The temperature-pressure relief valve drain line is missing on the garage located on demand water heater. This is a potential safety hazard due to the risk of scalding if someone is standing next to the water heater when the valve opens. Recommend that a qualified plumber install the TPR valve piping per manufacturers instructions and per

Photo 21-1  
TPR valve missing piping.

standard building practices. For example, by extending the drain line to within 6 inches of a drain or to the building exterior.

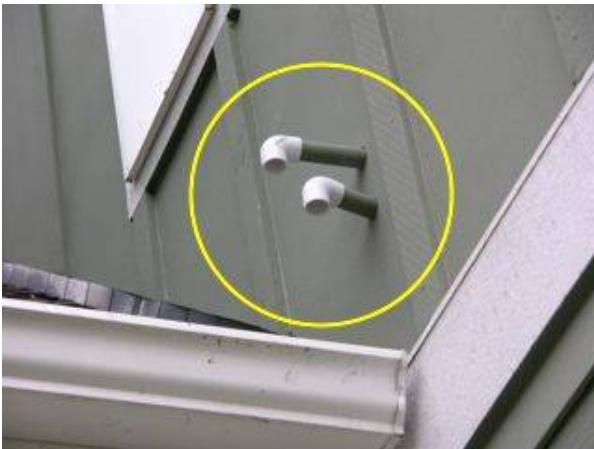
The temperature-pressure relief valve drain lines for the residence water heaters are positioned in a area where they can direct hot water to someone below the discharge pipe. This is a potential safety hazard due to the risk of scalding if someone is standing in the area of the water heater when the valve opens. Recommend that a qualified plumber install the TPR valve piping per manufacturers instructions and per standard building practices. For example, by extending the drain line to within 6 inches of a drain or ground.

Photo 22-1  
Temperature pressure relief valve piping can discharge to persons below.

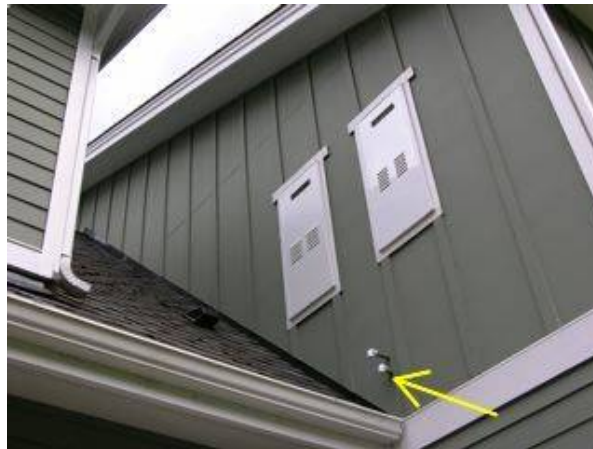
Photo 22-2  
Hot water can discharge to persons below.

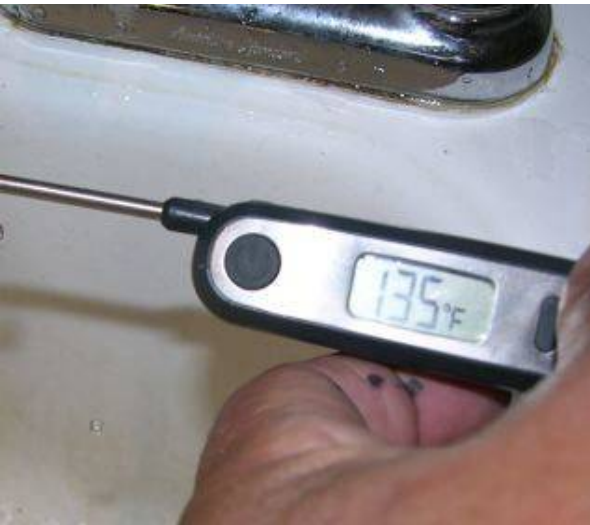
Photo 23-1

The hot water temperature was greater than 120 degrees Fahrenheit. This is a safety hazard due to the risk of scalding. The thermostat should be adjusted so the water temperature doesn't exceed 120 degrees. If the water heater is powered by electricity, a qualified person should perform the adjustment, since covers that expose energized equipment normally need to be removed. For more information on scalding dangers, visit:

Water temperature at 135 degrees.

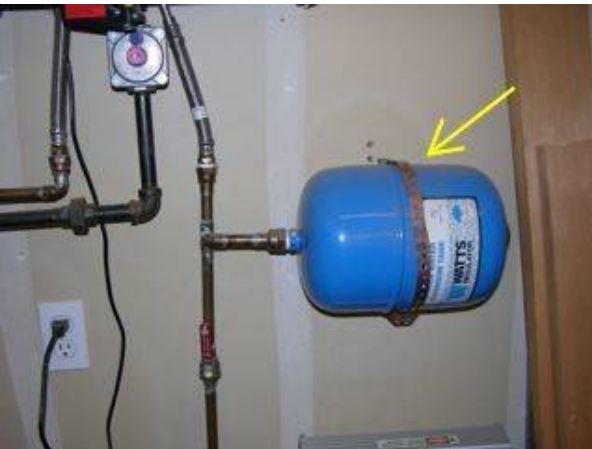
Photo 24-1

The garage located on demand water heater expansion tank is not properly secured. Recommend that a qualified person review and repair as required.

Expansion tank not properly supported.

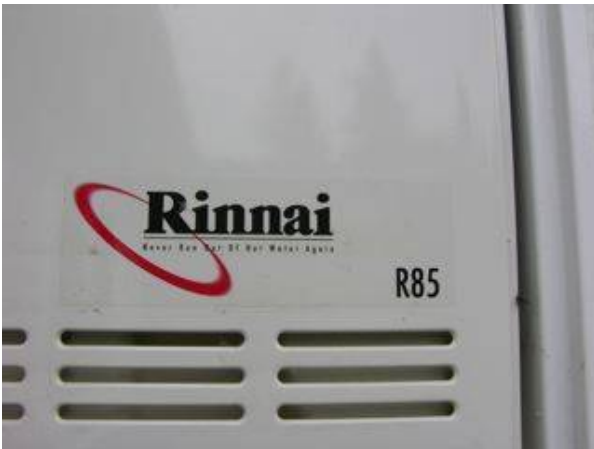
The residence is equipped with twin Rinnai R-85 tankless water heaters. Recommend that the client review all available documentation for this tankless water heater and remote controls. Depending on how they are operated, these units may need periodic maintenance that has to be performed by a service technician. Consult with the property owner and/or a qualified specialist to determine if service is needed now.

Photo 25-1  
Rinnai tankless water heaters

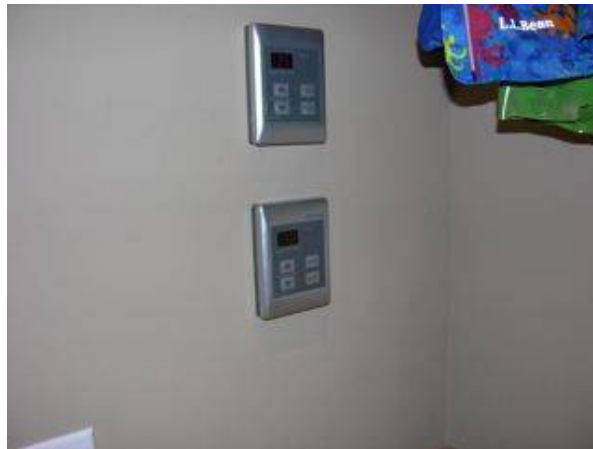
Photo 25-2  
Remote controls for the Rinnai water heaters located in the laundry room.

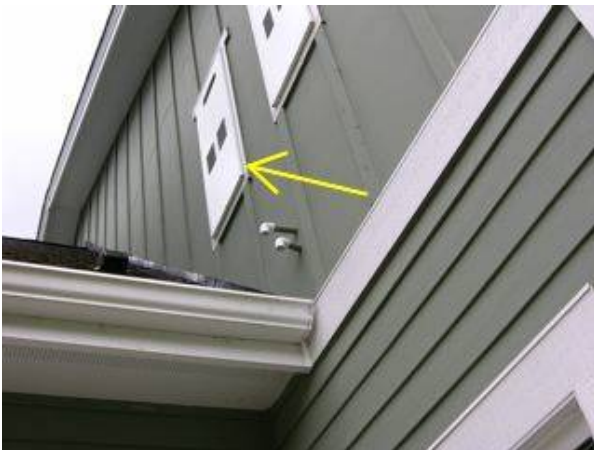
26) The inspector was unable to open the cover on one of the water heaters located at the back of the residence. The interior condition is excluded from this inspection. Recommend a qualified service technician review and repair.

Photo 26-1  
Unable to remove the panel on this water heater.

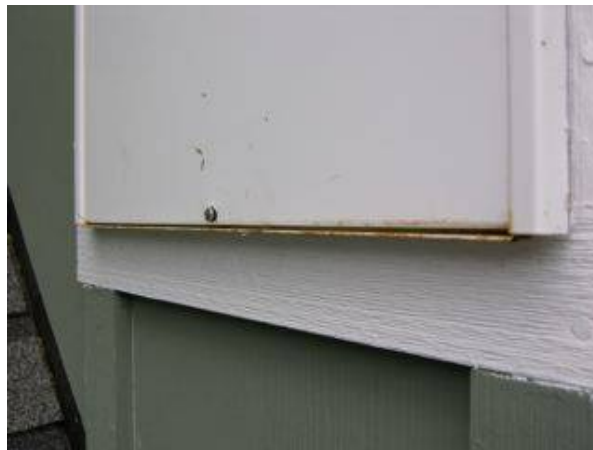
Photo 26-2  
Bottom of the tankless water heater cover corroded. Unable to open.

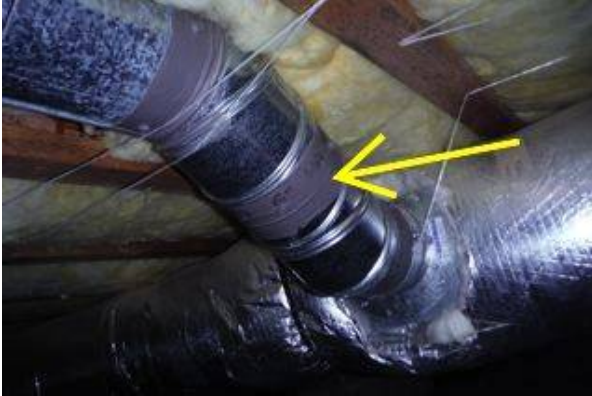
One or more heating or cooling ducts in the crawl space were not insulated. This can result in reduced energy efficiency, moisture inside heating ducts, and/or "sweating" on cooling ducts. Recommend that a qualified person repair per standard building practices. For example, by wrapping ducts in insulation with an R-value of R-8.

Photo 27-1  
 Heating ducts in the crawl space missing insulation

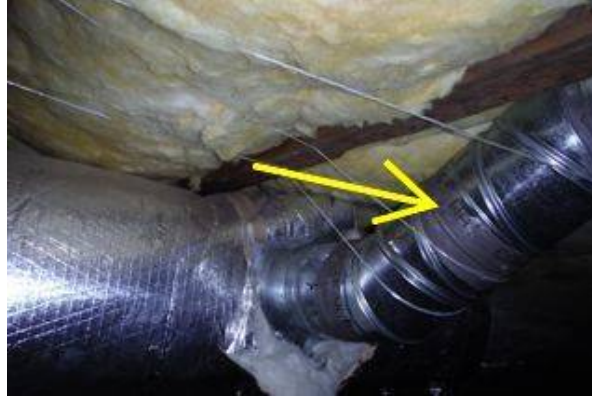
Photo 27-2  
 Heating ducts in the crawl space missing insulation.

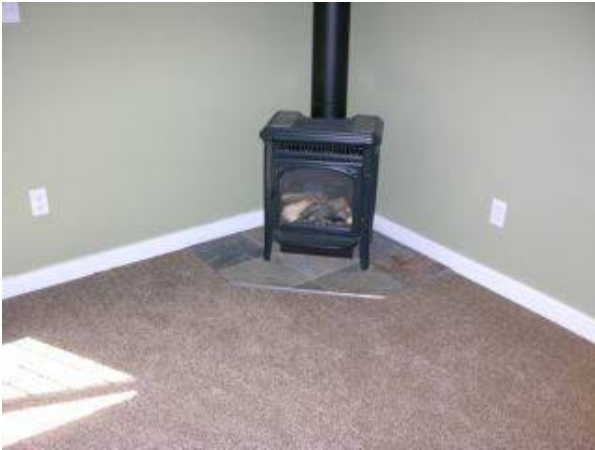
Photo 30-1

Recommend that the client review all available documentation for gas-fired fireplaces and stoves. Depending on how they are operated (for routine heating versus ambiance), such appliances normally need servicing

Free standing gas fireplace located in the bonus room above the garage.

annually or every few years. Consult with the property owner and/or a qualified specialist to determine if service is needed now.

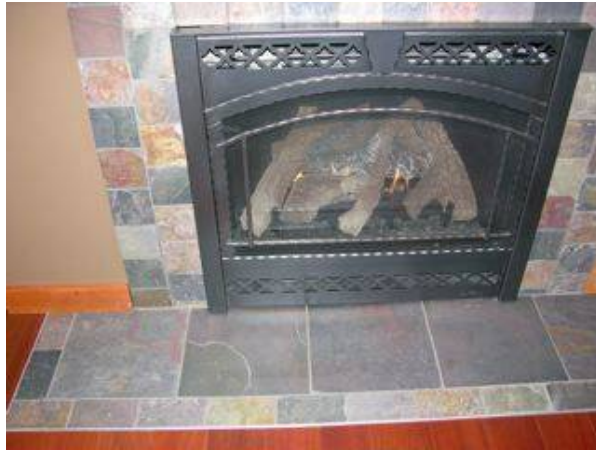
Photo 30-2

Gas fireplace located in the living room.

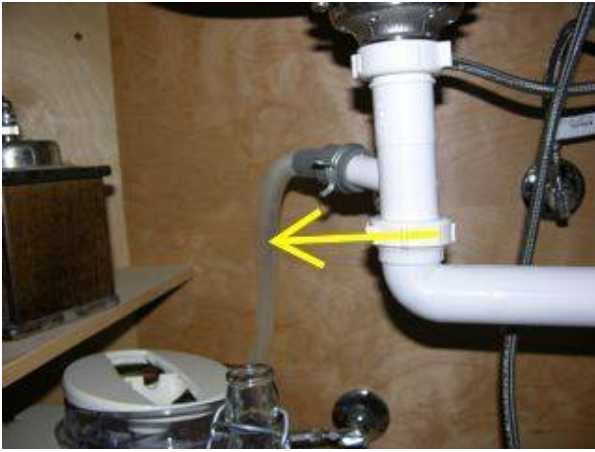
No high loop or air gap was visible for the dishwasher drain in the downstairs kitchen. A high loop is created by routing the drain line up to the bottom surface of the counter top above and securely fastening it to that surface. An air gap is a device that makes the drain line non-continuous. Both of these prevent waste-water backflow from entering the dishwasher, and possibly flooding out of the dishwasher if/when a siphon occurs. Some newer dishwashers have these devices built in. The client should try to determine if these devices are built in to this brand and model of dishwasher (e.g. review installation instructions). If not, or if this cannot be determined, then recommend that a qualified contractor install a high loop and air gap per standard building practices.

Photo 32-1  
Dishwasher drain missing air gap or high loop

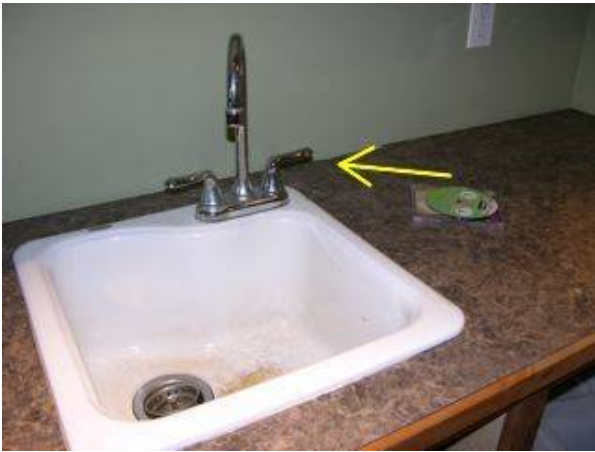
34) 🔧 Backsplashes were missing in the upstairs kitchen. Recommend repairing or replacing as necessary.

Photo 34-1  
Back splash missing in the upstairs kitchen.

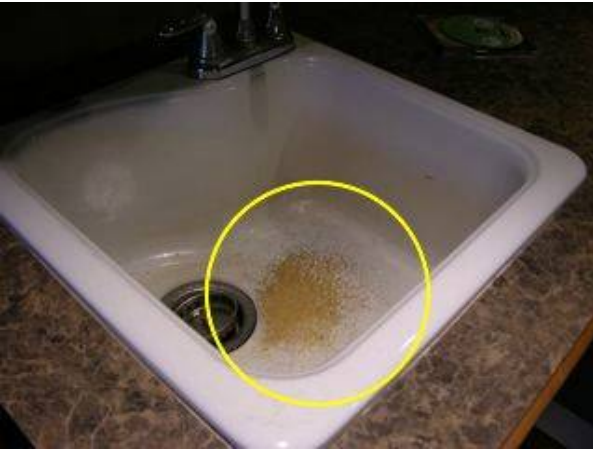
36) 🔧 The sink in the kitchen over the garage was damaged or significantly deteriorated. Recommend that a qualified contractor replace the sink.

Photo 36-1  
 Damaged kitchen sink (kitchen above the garage)

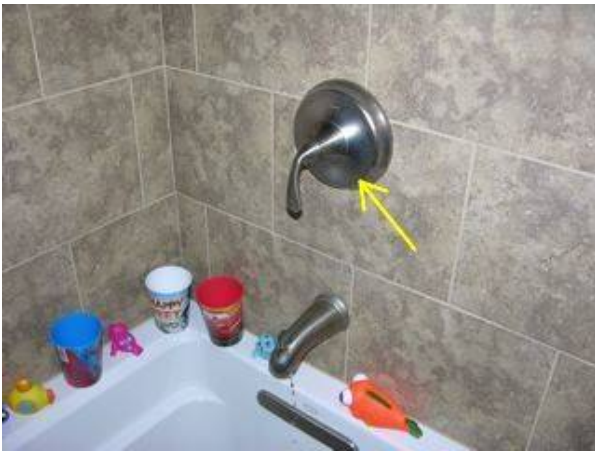
The hot and cold water supplies appeared to be reversed at the bathtub at location(s) #C. Normally, cold water is controlled by the right faucet handle and hot by the left. For mixing faucets, cold is supplied with the handle to the right and hot when the handle is to the left, or as indicated by the faucet's markings. At a minimum this is an inconvenience, but it can also result in accidental scalding. Recommend that a qualified plumber repair as necessary.

Photo 37-1  
Direction of hot and cold reversed.

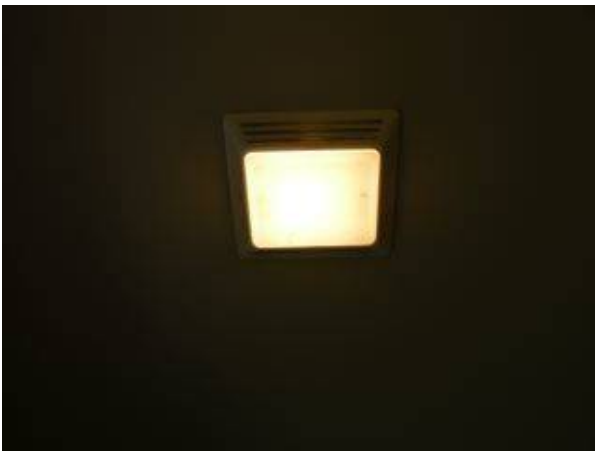
The exhaust fan at location(s) #B (bath over the garage) was noisy. Moisture may accumulate and result in mold, bacteria or fungal growth. Recommend that a qualified person clean, repair or replace fans as necessary.

Photo 38-1  
Fan in the bathroom located over the garage is noisy.

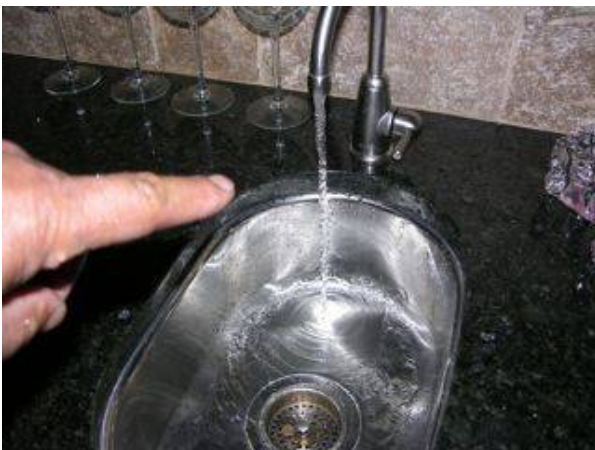
The faucet for the downstairs bar sink is loose. Recommend that a qualified person repair as needed.

Photo 39-1  
Faucet is loose.

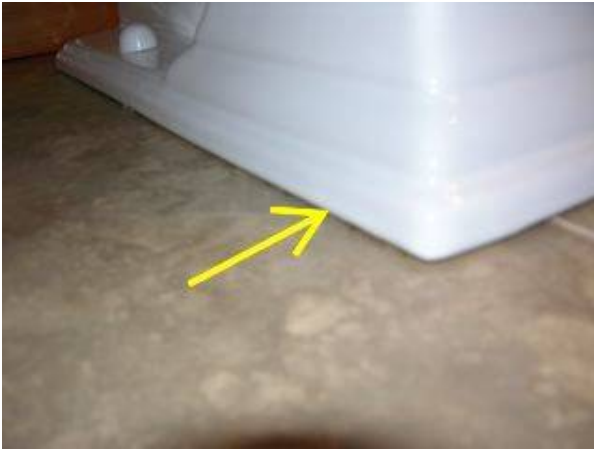
Caulk around the base of the toilet at location(s) #A, C was missing, substandard and/or deteriorated. Modern standards require caulk to be installed around the entire toilet base where it meets the floor for sanitary reasons. Without it, soiled water can soak into flooring and sub-floor materials if the toilet overflows. Condensation from the toilet can also soak into the flooring. Recommend that a qualified person caulk around toilet bases per standard building practices.

Photo 40-1  
Caulking missing at the base of the toilet.

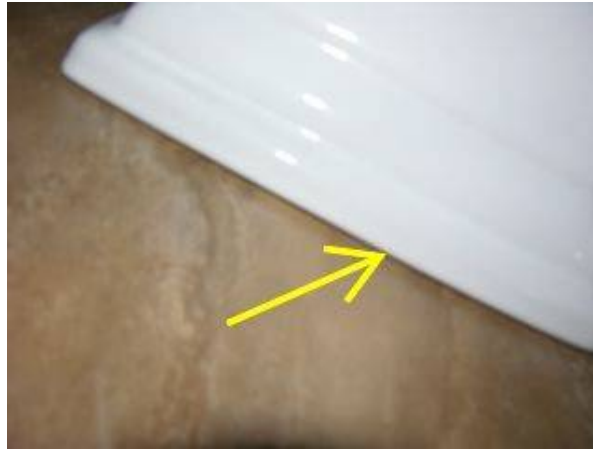
Photo 40-2  
Caulking missing at the base of the toilet

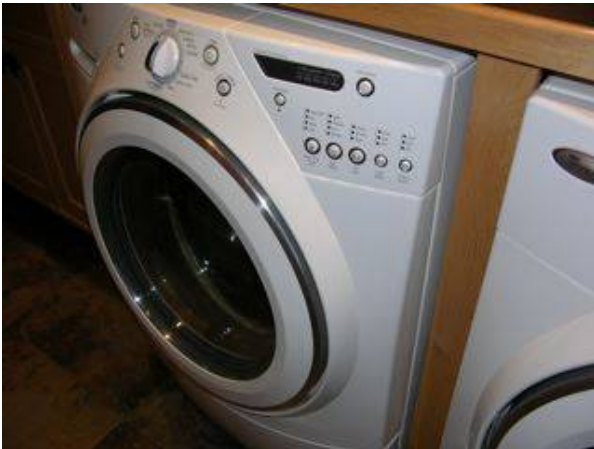
The washer and dryer in the laundry room are built in under a counter top. The inspector is unable to inspect the plumbing, venting and electrical connections.

Photo 41-1  
Under counter washer and dryer.

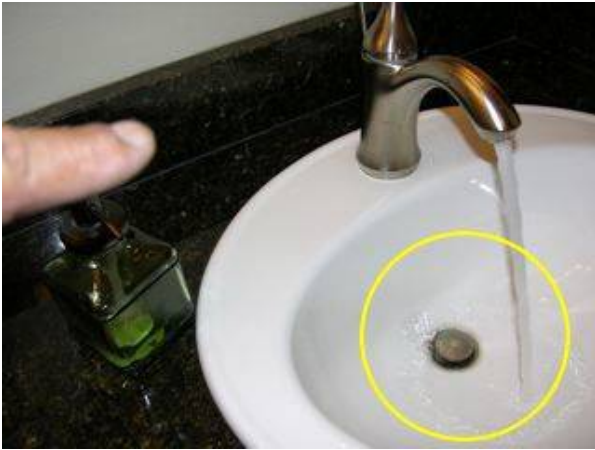
42) The sink stopper in the upstairs guest bath does not work properly. Recommend that a qualified person repair or adjust as required.

Photo 42-1  
Stopper on the right sink not functioning.

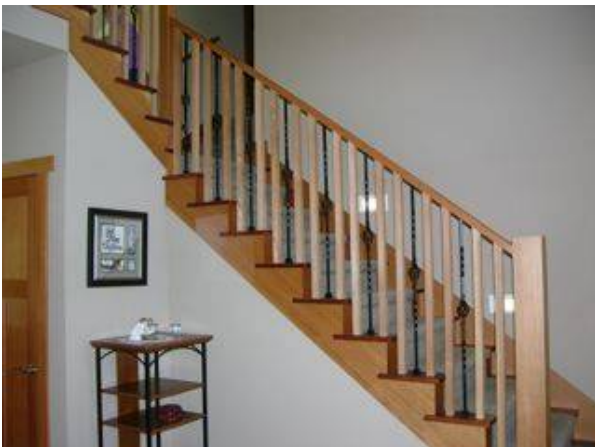
Photo 43-1

Handrails at one or more flights of stairs were loose, wobbly. This is a safety hazard. Recommend that a qualified person repair as necessary.

Stair handrails are loose.

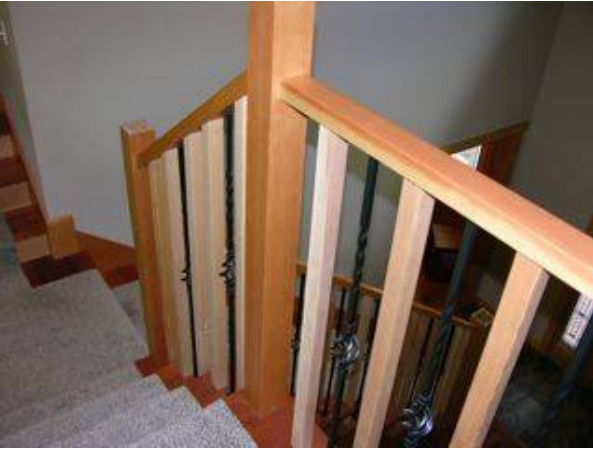
Photo 44-1

Guardrails at one or more locations with drop-offs higher than 30 inches were loose, wobbly, and pose a fall hazard. Recommend that a qualified person repair guardrails as necessary.

Guardrails are loose

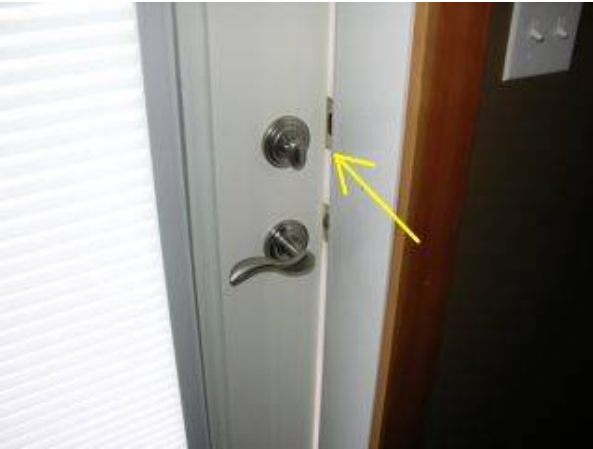
Photo 45-1

The exterior door leading off the Master bedroom is out of adjustment and does not seal on the weather stripping properly. Recommend that a qualified person repair as necessary.

Exterior door off the master bedroom does not seal on the weather stripping.

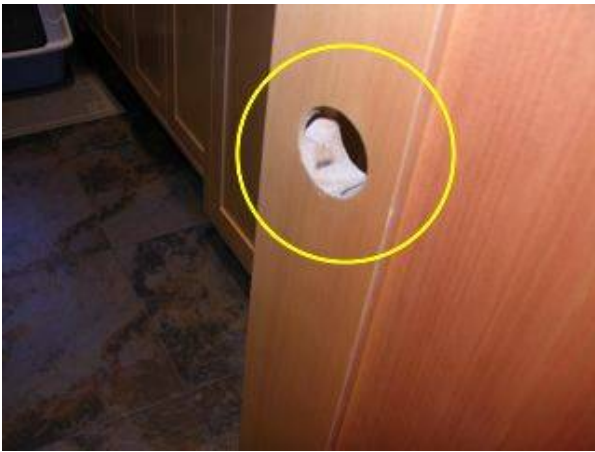
The laundry room door is missing the lockset. Recommend that a qualified person repair or replace as necessary.

Photo 46-1  
Laundry room door missing hardware

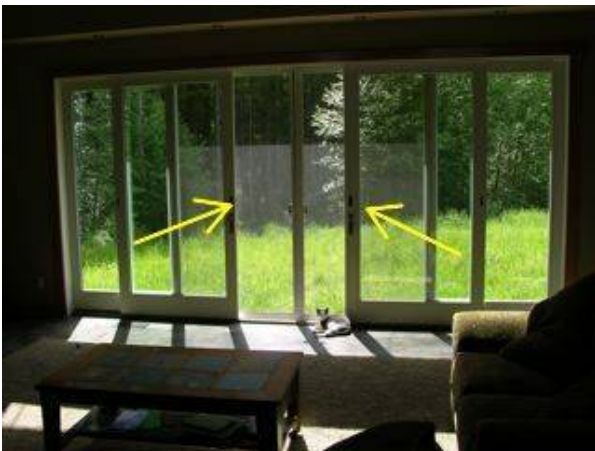
The sliding glass door in the living room is difficult to open and close. Recommend that a qualified person maintain, repair or replace door(s) as necessary. Often, cleaning the track and applying a lubricant will help.

Photo 47-1  
Sliding glass door difficult to open and close.

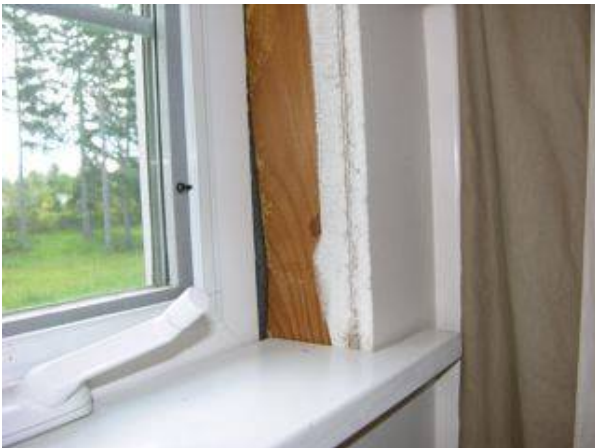
A significant amount of trim is missing around the windows and doors upstairs. Recommend that a qualified person install as required.

Photo 48-1  
Missing trim.

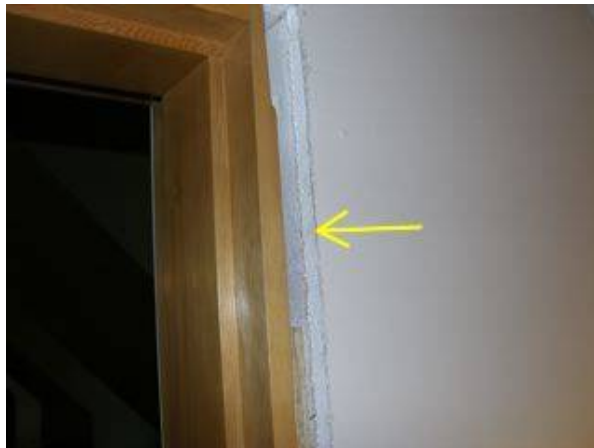
Photo 48-2  
Missing door trim.
